Section 22 Connecticut

Connecticut Coastal Structures Inventory Study

PHASE I - NEW LONDON COUNTY

APPENDIX B
MYSTIC QUADRANGLE
RECORDS OF STRUCTURES WITH PHOTOGRAPHS

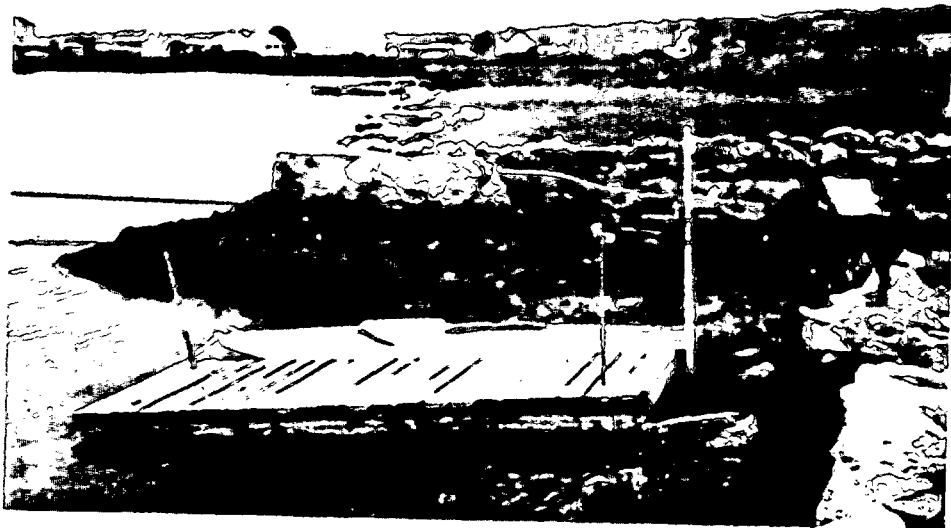
MY 77.00 #1

TYPE OF STRUCTURE: SEAWALL CONDITION: POOR
MAIN FUNCTION : RETENTION AND PROTECTION
MATERIAL : CEMENTED ROCKS

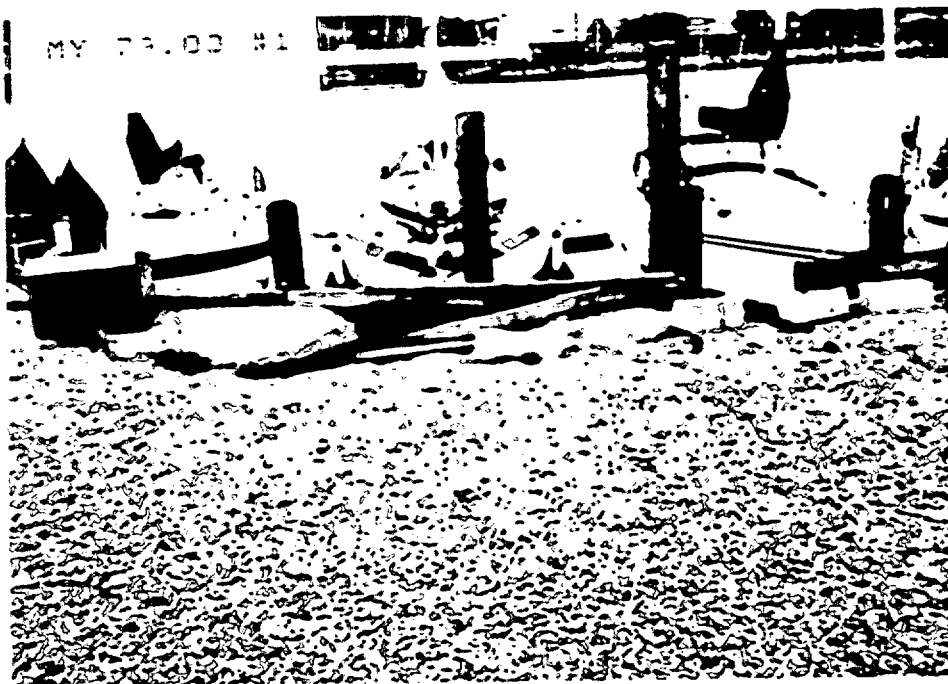
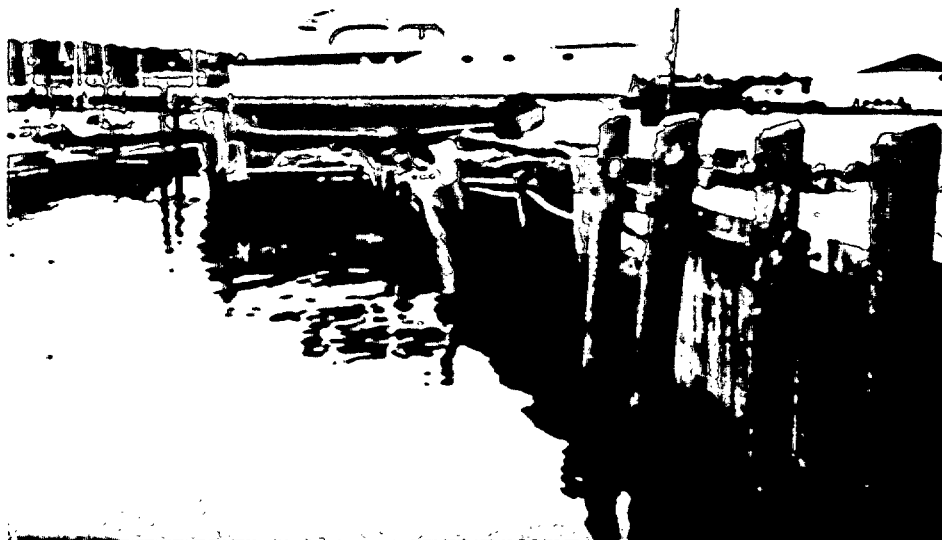
BREWER'S YACHT YARD

TYPE OF STRUCTURE: BULKHEAD CONDITION: GOOD-POOR
MAIN FUNCTION : RETENTION
MATERIAL : WOOD

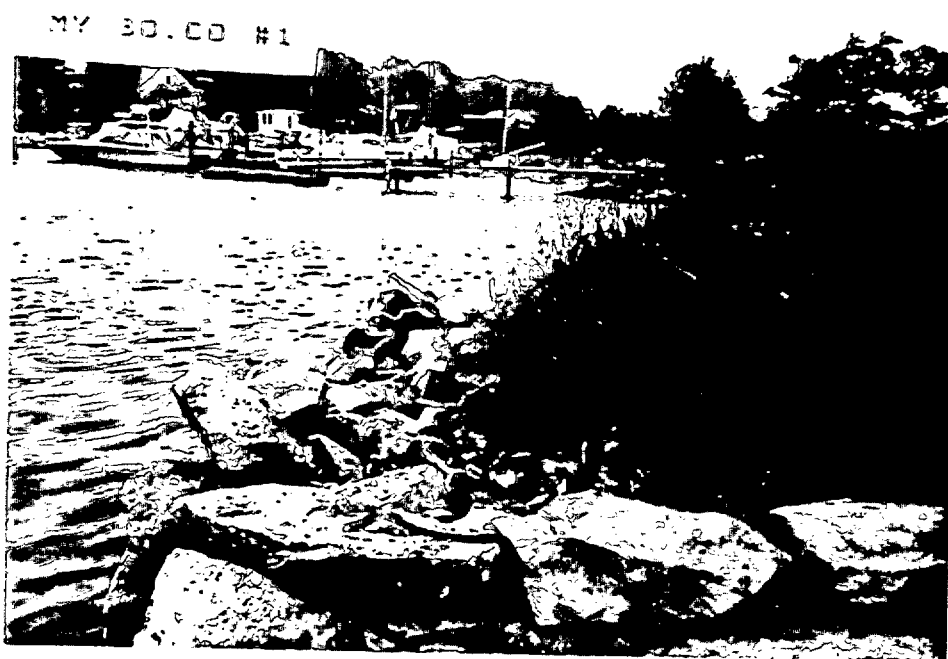
TYPE OF STRUCTURE: REVETMENT CONDITION: POOR
MAIN FUNCTION : SLOPE EROSION PROTECTION
MATERIAL : ROCK

ADJACENT TO BENCHMARK, 700 YARDS FROM RAILROAD DIKE.

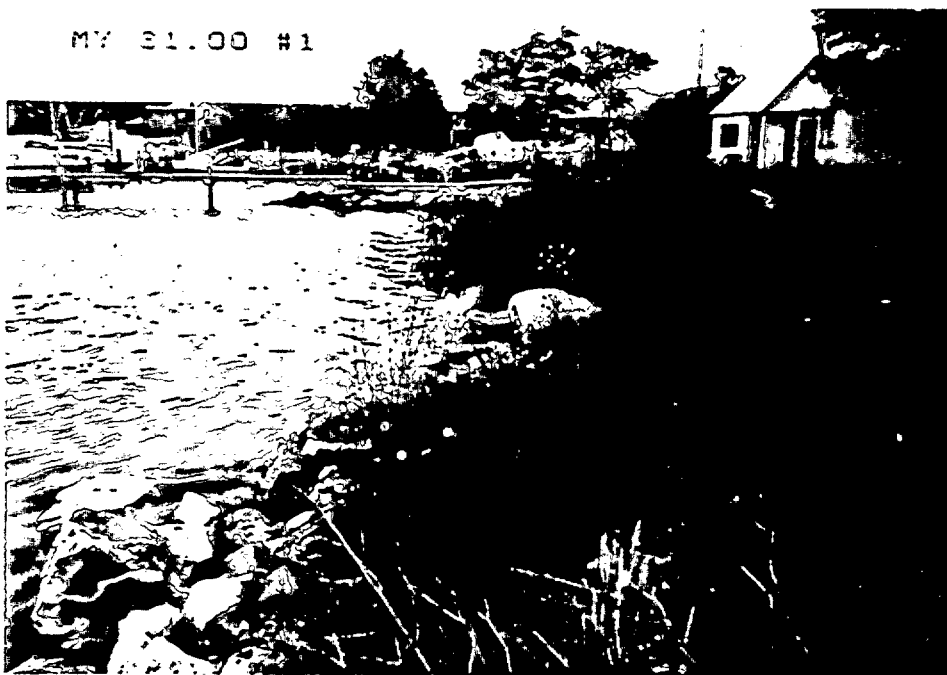
MY 31.00 #1

TYPE OF STRUCTURE: BULKHEAD CONDITION: POOR
MAIN FUNCTION : SHORE STABILIZATION
MATERIAL : WOOD AND ROCK

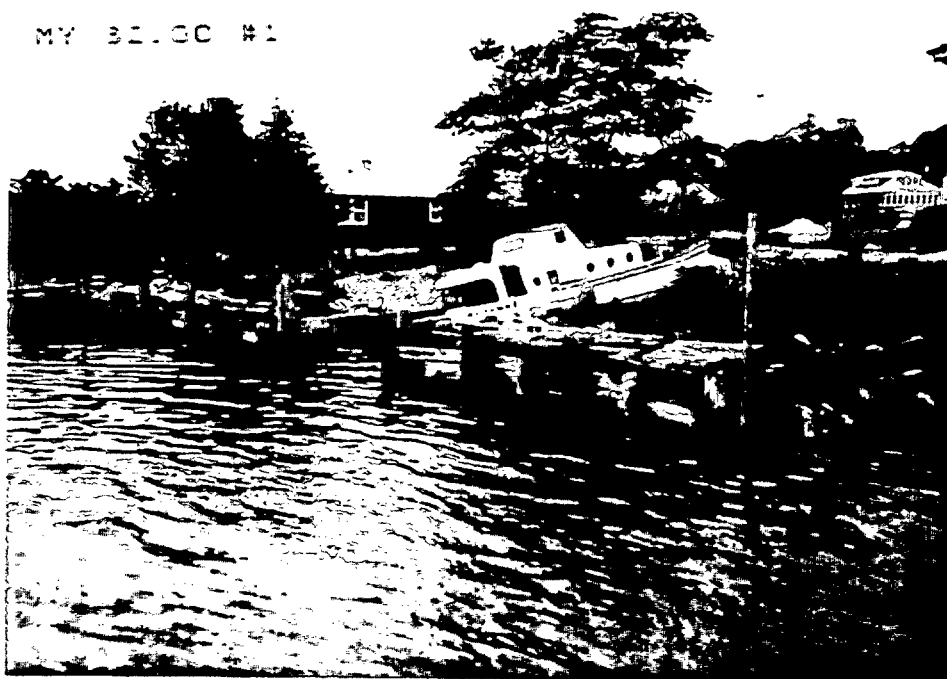
MY 32.00 #1

TYPE OF STRUCTURE: BULKHEAD CONDITION: GOOD
MAIN FUNCTION : SLOPE STABILIZATION AND EROSION PROTECTION
MATERIAL : STONES&CEMENT

WILLOW POINT MARINA DOCK ADJACENT #82 NO PERMIT (H. WITZZ)
ARLENE BULCER DOCK ON OTHER SIDE - NO PERMIT FOR DOCK
EXTENSION.

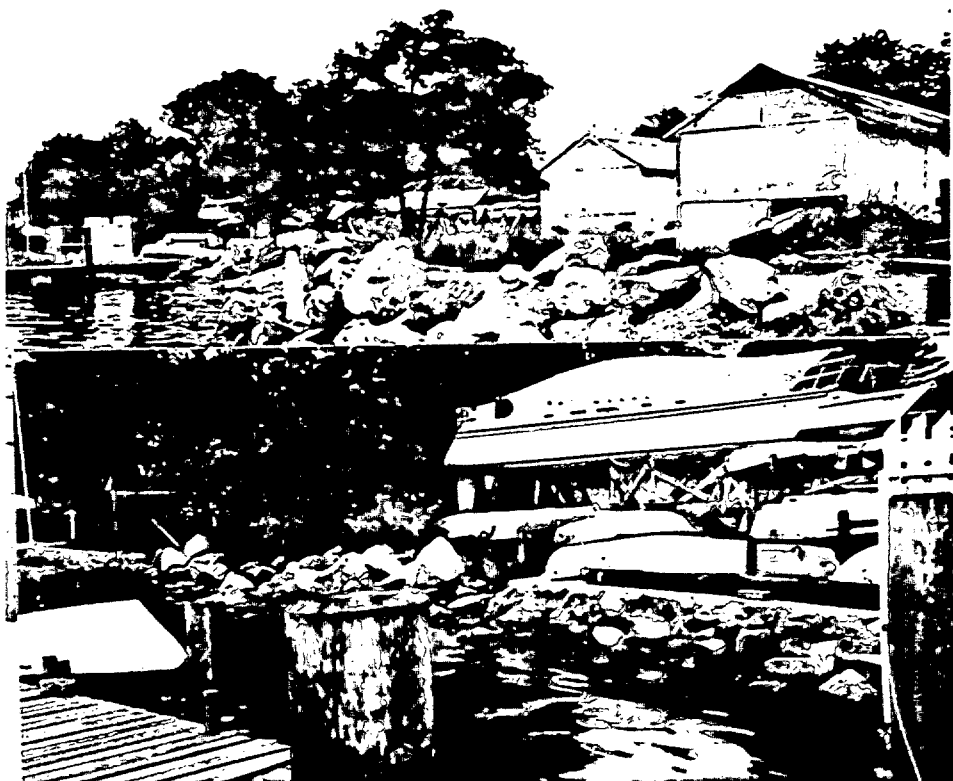
MY 25.00 #1

TYPE OF STRUCTURE: REVETMENT&WALL CONDITION: FAIR
MAIN FUNCTION : SLOPE STABILIZATION AND EROSION PREVENTION
MATERIAL : STONE&CONCRETE

MYSTIC YACHT CENTER

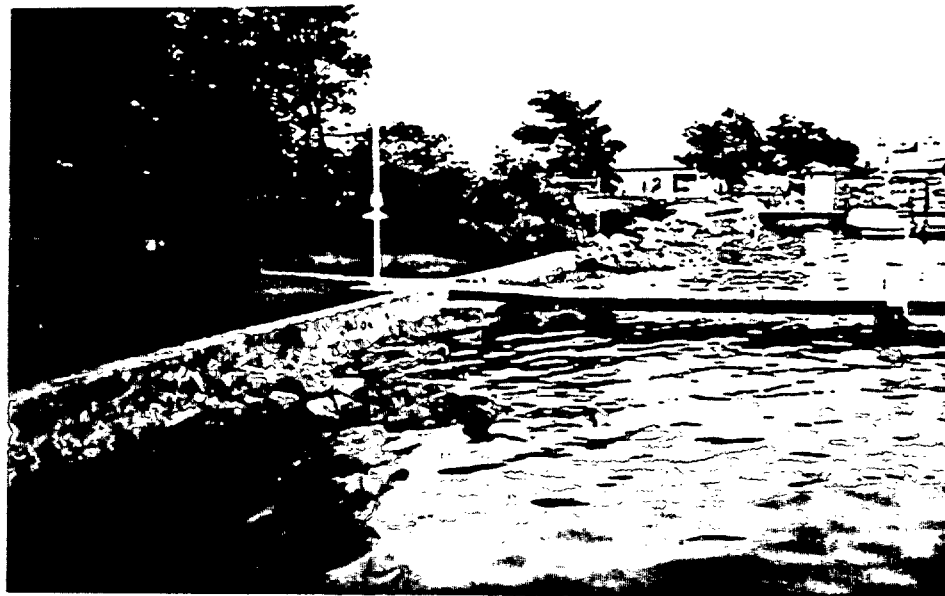
MY 36.00 #1

TYPE OF STRUCTURE: SEAWALL CONDITION: FAIR
MAIN FUNCTION : SLOPE STABILIZATION AND EROSION PREVENTION
MATERIAL : STONE&CEMENT

SOME SCOURING IN BACK OF STRUCTURE

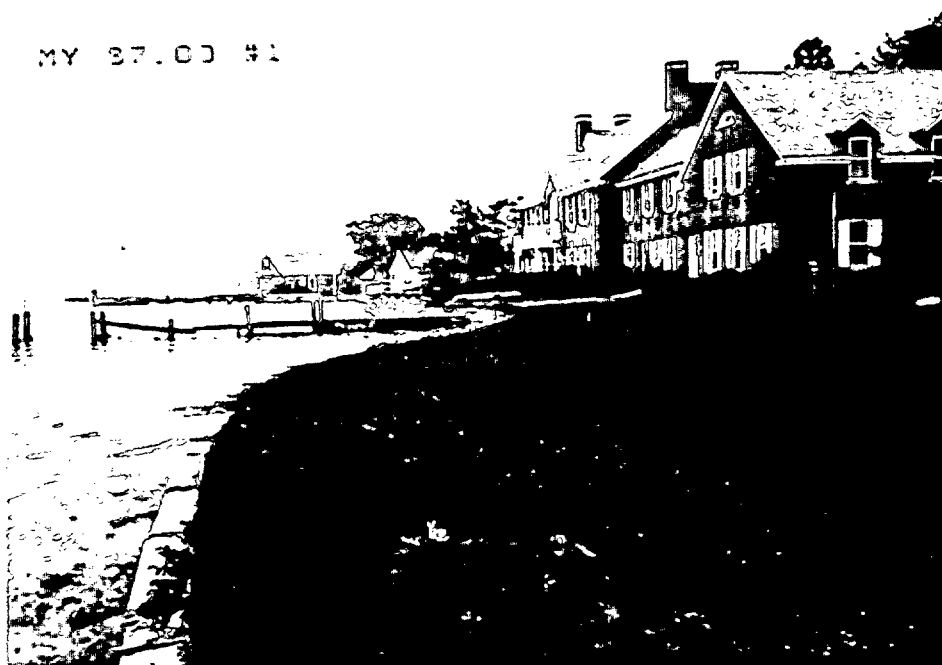
MY 37.00 #1

TYPE OF STRUCTURE: SEAWALL CONDITION: FAIR
MAIN FUNCTION : SLOPE STABILIZATION, RETENTION, EROSION PREVENTION
MATERIAL : STONE&CEMENT

SOME BACKSIDE SCOUR

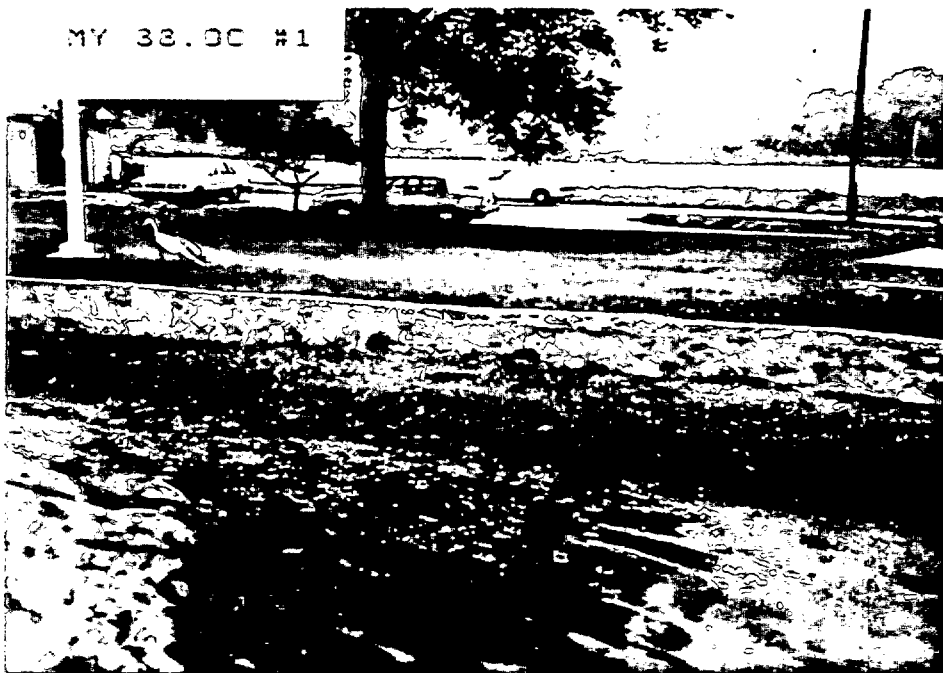
MY 38.00 #1

TYPE OF STRUCTURE: SEAWALL CONDITION: GOOD
MAIN FUNCTION : SLOPE STABILIZATION, PREVENT EROSION, PROTECT SHOR
MATERIAL : STONE&CEMENT

NOTED BACK SCOUR OCCURS AT WALLS ON SPENCE POINT

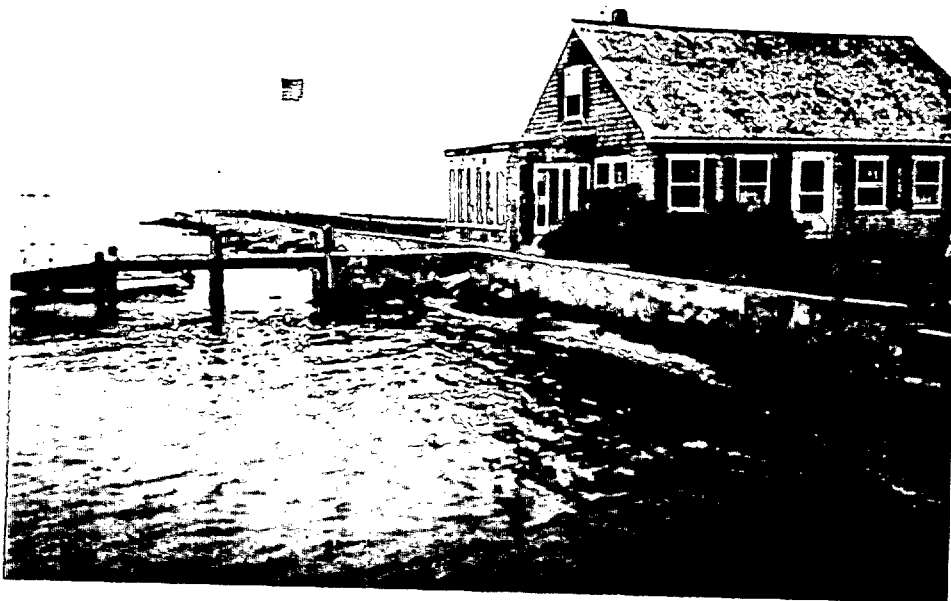
MY 39.00 #1

TYPE OF STRUCTURE: SEAWALL CONDITION: GOOD
MAIN FUNCTION : EROSION PROTECTION AND SHORE STABILIZATION
MATERIAL : STONE&CEMENT

SEAWALL EXTENDS AROUND PERIMETER OF PROPERTY (SPENCER POINT)
RIPRAP AT SOME PLACES

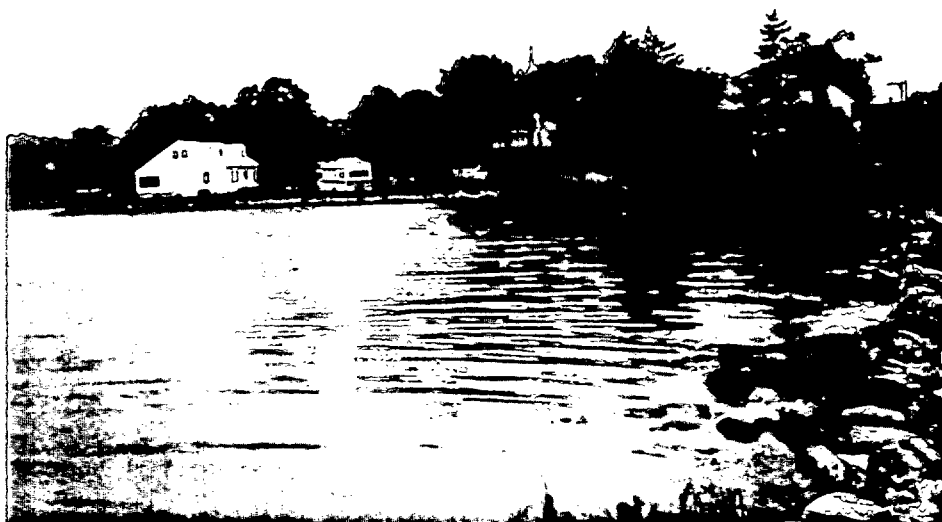
MY 90.00 #1

TYPE OF STRUCTURE: RIPRAP CONDITION: FAIR
MAIN FUNCTION : SHORE EROSION PROTECTION
MATERIAL : STONE

THIS CONCLUDES SPENCE POINT - THE REST OF THE AREA IS MARSH
WITH RAILROAD DIKE RUNNING PARALLEL TO SHORE. SIX PENNY
ISLAND SIGHTED FROM SHORE - NO STRUCTURE SEEN.

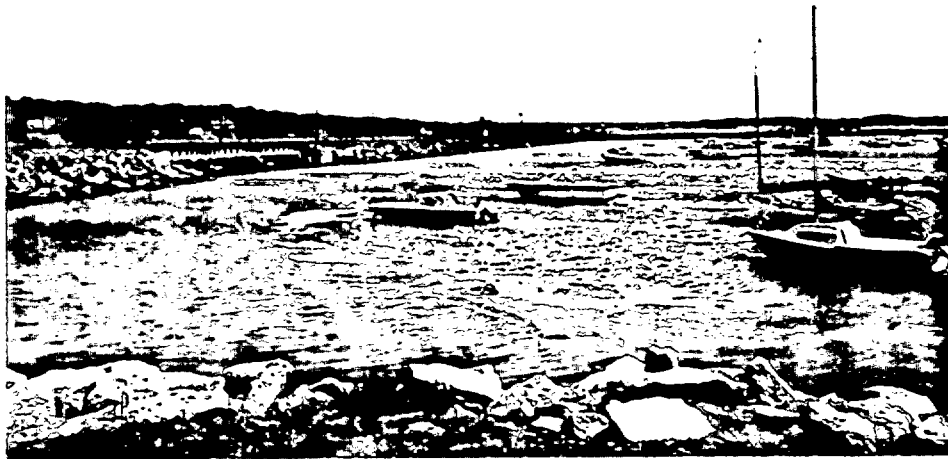
MY 91.00 #1

TYPE OF STRUCTURE: RIPRAP CONDITION: GOOD
MAIN FUNCTION : SLOPE STABILIZATION AND EROSION PREVENTION
MATERIAL : STONE

AT NOANK VILLAGE BOAD YARD
REVTMENT COMPOSED OF RIPRAP SLOPE

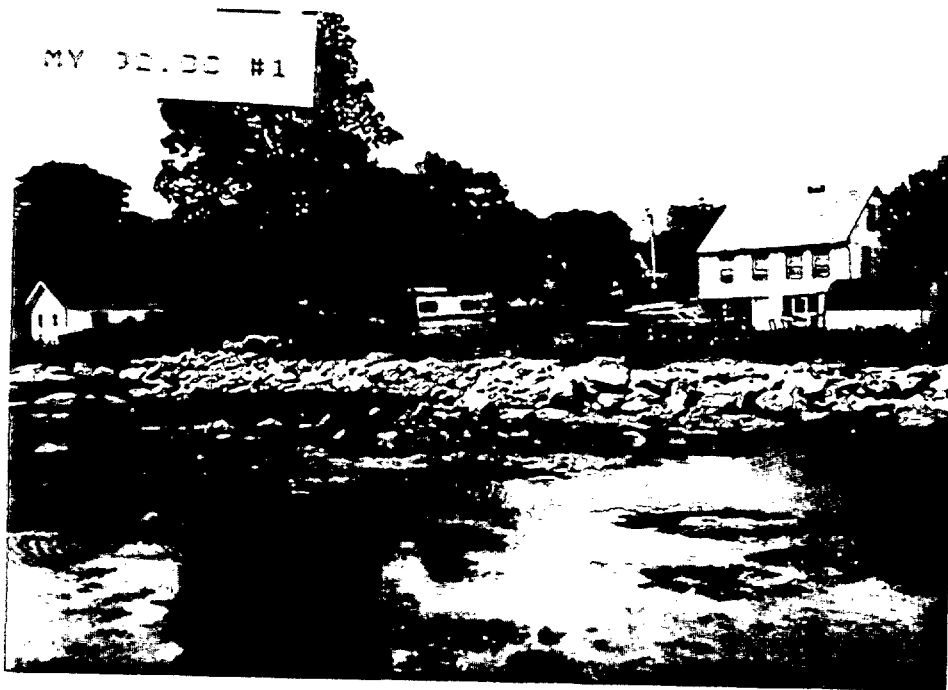
TYPE OF STRUCTURE: RIPRAP CONDITION: GOOD
MAIN FUNCTION : SLOPE STABILIZATION
MATERIAL : STONE

#1 ROLL 8 NEG 23 STRUCTURE LOOKING SOUTH FROM PIER TO NORTH
#2
#3
#4
#5

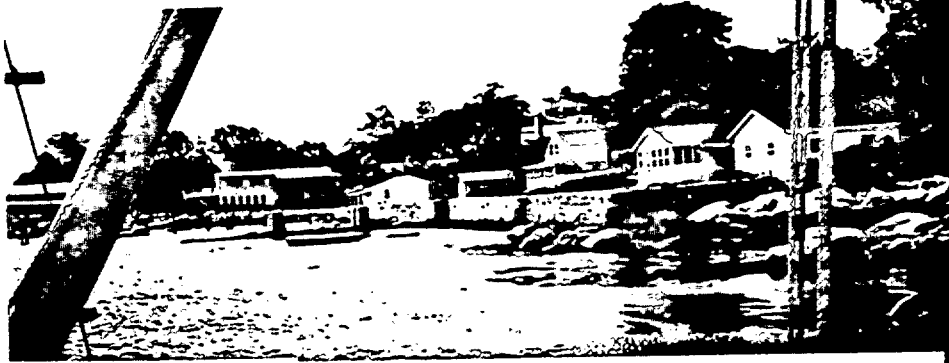
MY 93.00 #1

TYPE OF STRUCTURE: SEAWALL&DOCK CONDITION: GOOD
MAIN FUNCTION : SHORE PROTECTION
MATERIAL : CEMENTED ROCK

#1 ROLL 8 NEG 24 SEAWALL FROM NOANK VILLAGE BOAT YARD-NOTE PIER
#2 ROLL 8 NEG 25 OLD DOCK FOUNDATION
#3 ROLL 8 NEG 26 SEAWALL
#4 ROLL 8 NEG 27 LOOKING SOUTH
#5

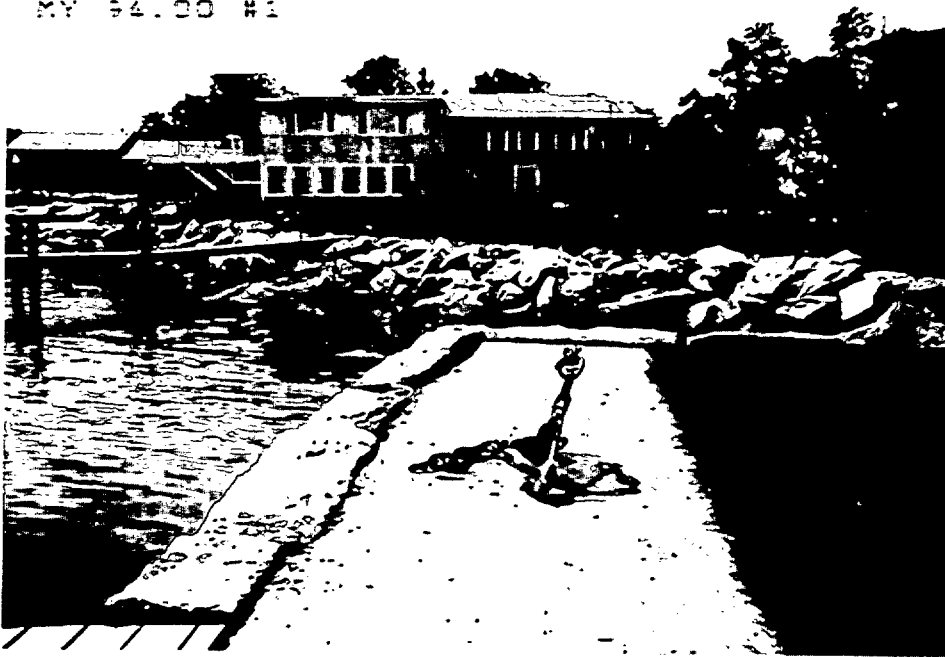
MY 94.00 #1

TYPE OF STRUCTURE: SEAWALL CONDITION: GOOD
MAIN FUNCTION : SHORE STABILIZATION AND EROSION PREVENTION
MATERIAL : CONCRETE

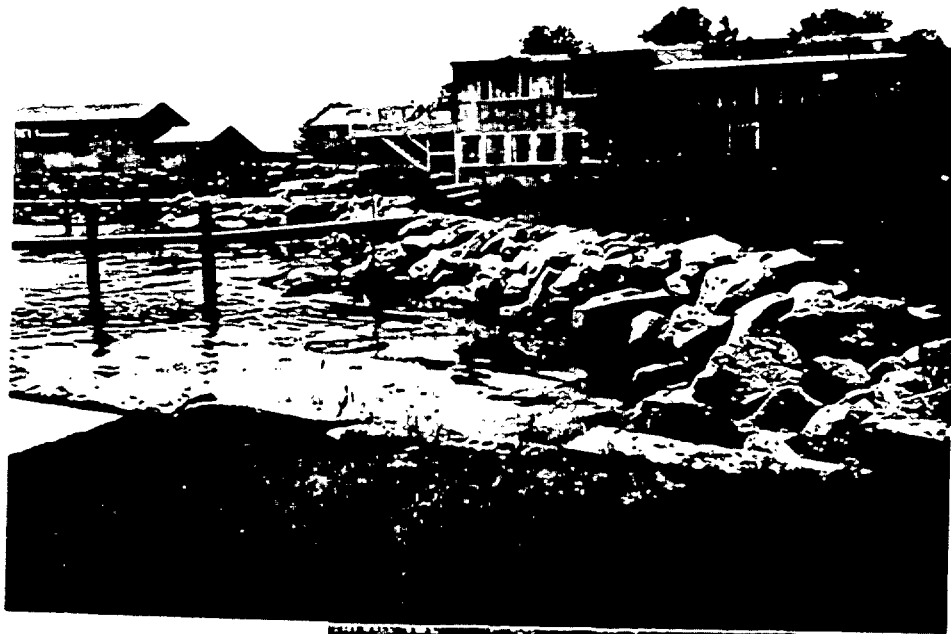
MY 95.00 #2

TYPE OF STRUCTURE: REVETMENT CONDITION: FAIR
MAIN FUNCTION : MAINTAIN SHORE FRONT AND PREVENT EROSION
MATERIAL : LARGE BOULDERS

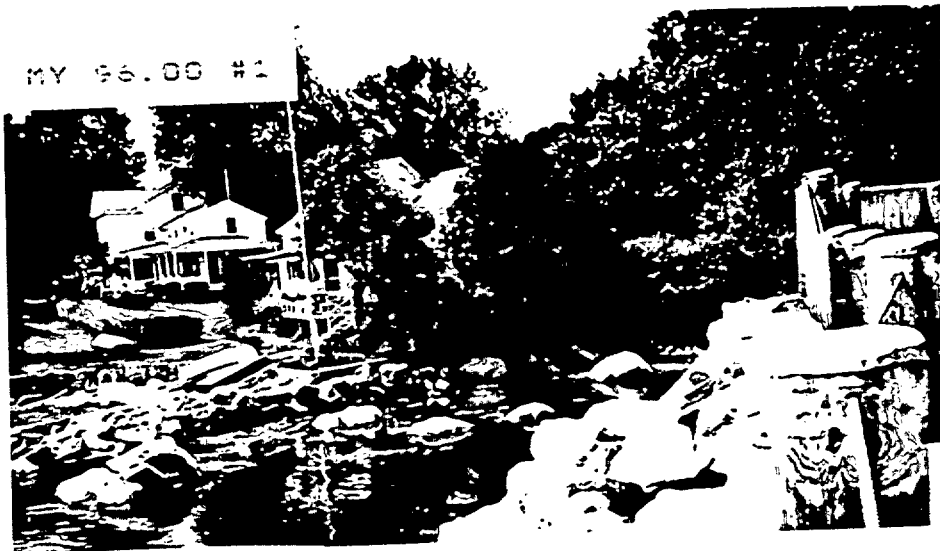
MY 96.00 #1

TYPE OF STRUCTURE: BULKHEAD CONDITION: GOOD
MAIN FUNCTION : SLOPE PROTECTION
MATERIAL : LARGE BOULDERS

WAS DOCK FOR TOWN BEFORE
DEVELOPED BY PRIVATE OWNER.

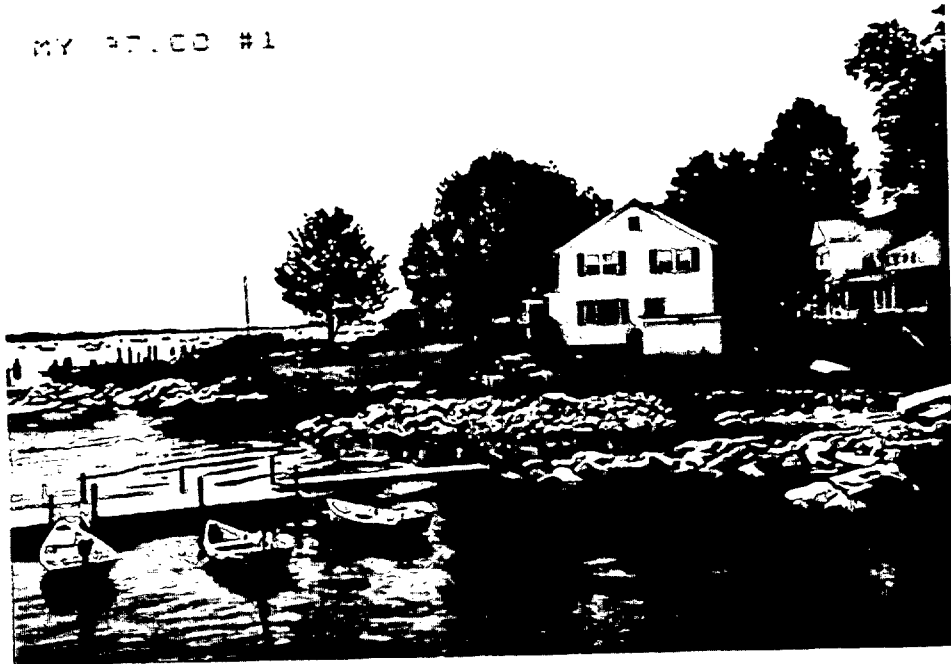
MY 97.00 #1

TYPE OF STRUCTURE: SEAWALL CONDITION: GOOD/FAIR
MAIN FUNCTION : RETAIN LAND AND PREVENT EROSION
MATERIAL : ROCK

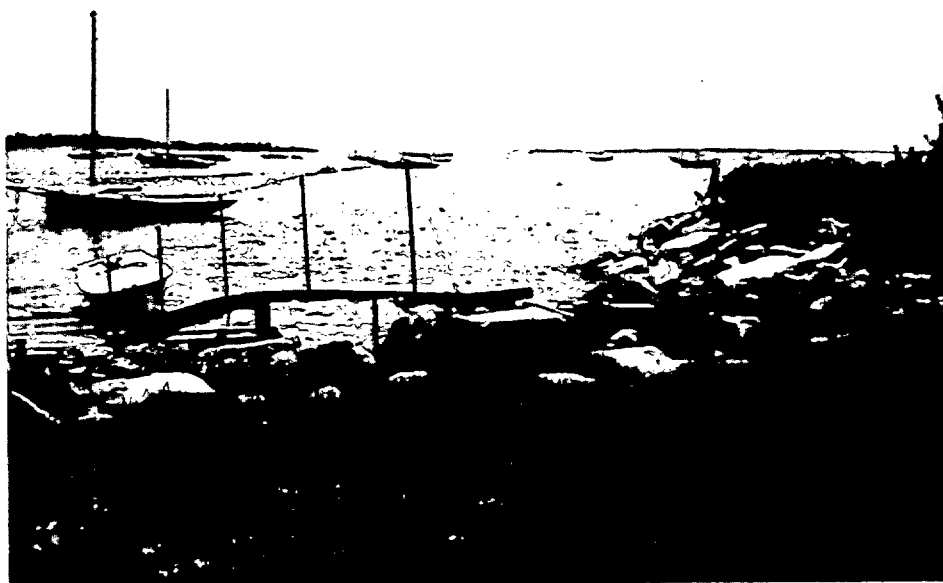
MY 92.00 #1

TYPE OF STRUCTURE: REVELTMENT CONDITION: GOOD
MAIN FUNCTION : PREVENT AND HALT EROSION
MATERIAL : ROCK

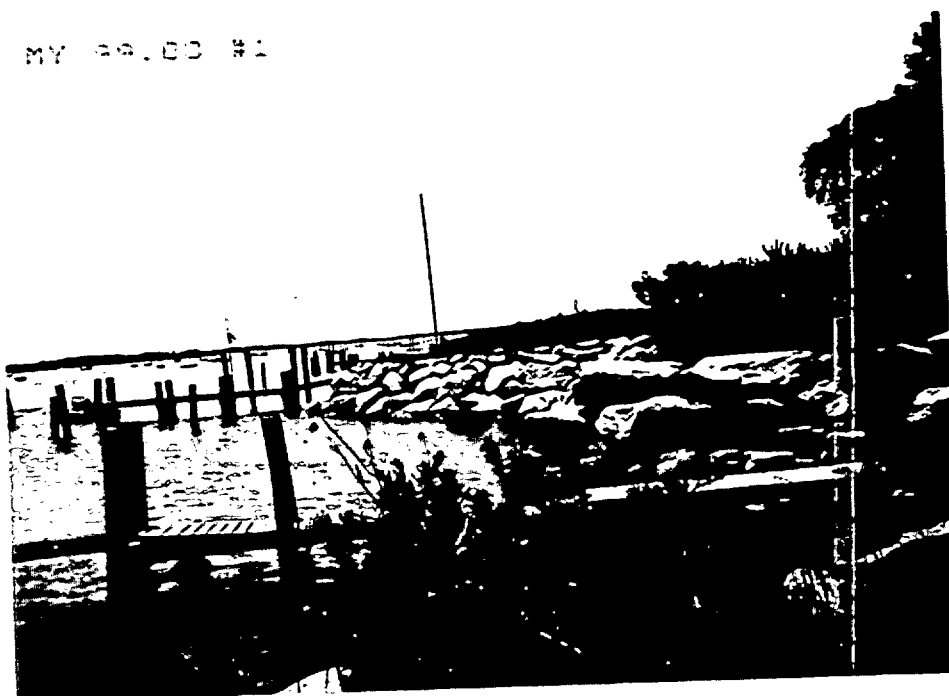
MY 09.00 #1

TYPE OF STRUCTURE: REVETMENT CONDITION: GOOD
MAIN FUNCTION : STABILIZE SLOPE AND PREVENT EROSION
MATERIAL : STONE

FOUNDATION FOR HOME ON BEDROCK. DOCK EXTENDS FROM REVETMENT

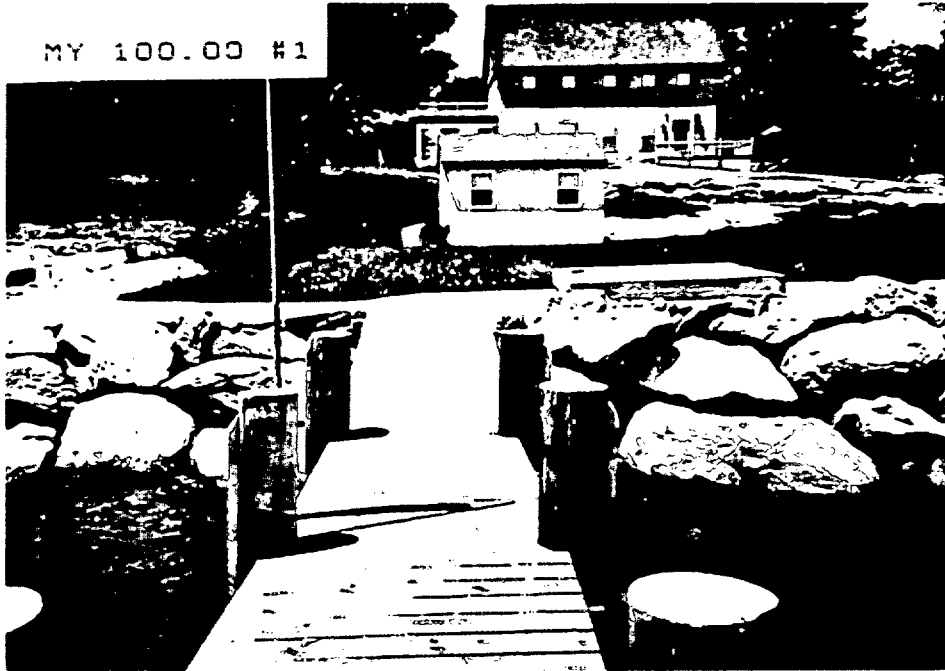
MY 100.00 #1

TYPE OF STRUCTURE: REVETMENT CONDITION: GOOD
MAIN FUNCTION : SLOPE PROTECTION AND EROSION PREVENTION
MATERIAL : STONE

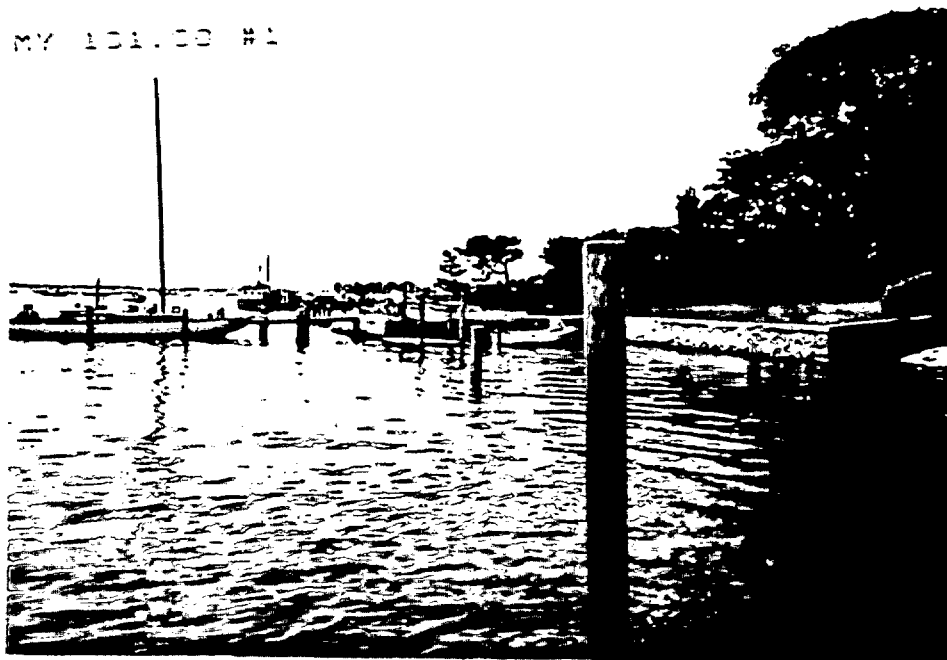
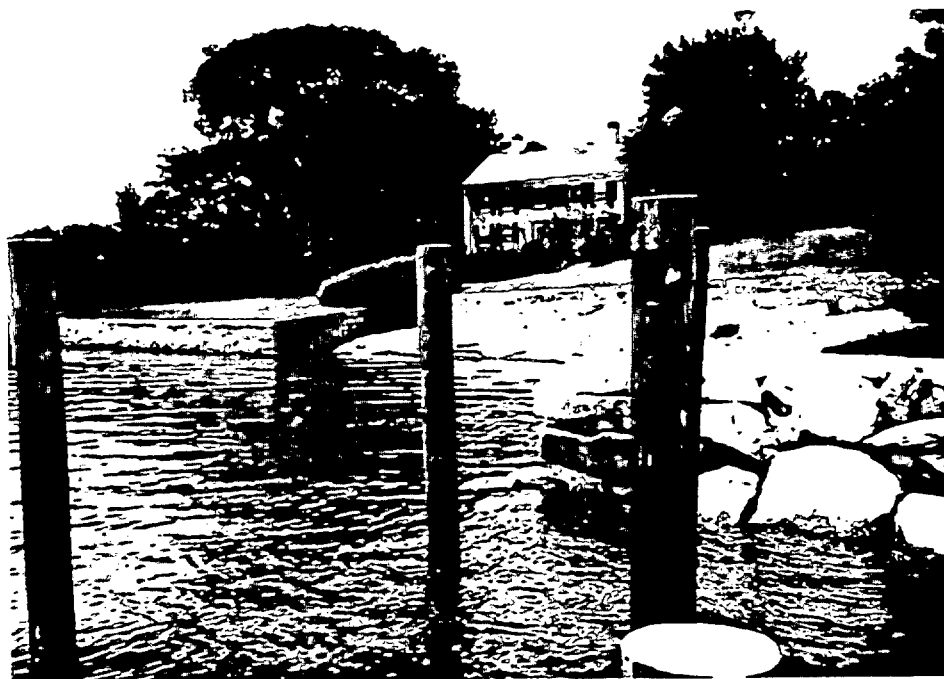
MY 101.00 #1

ADJACENT TO TOWN DOCK

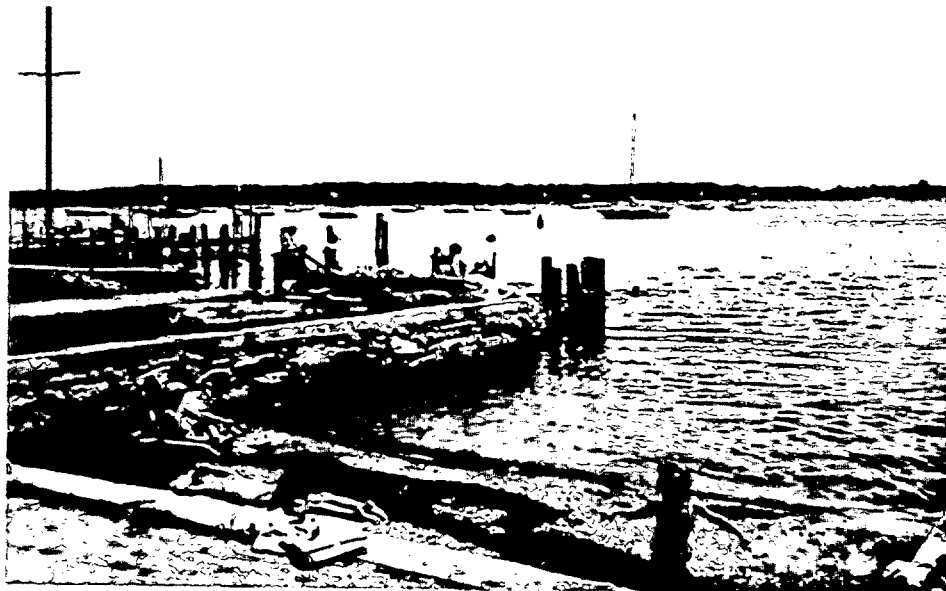
MY 102.00 #1

TYPE OF STRUCTURE: SEAWALL CONDITION: FAIR
MAIN FUNCTION : PROVIDE RECREATION AREA AND PREVENT EROSION
MATERIAL : STONE

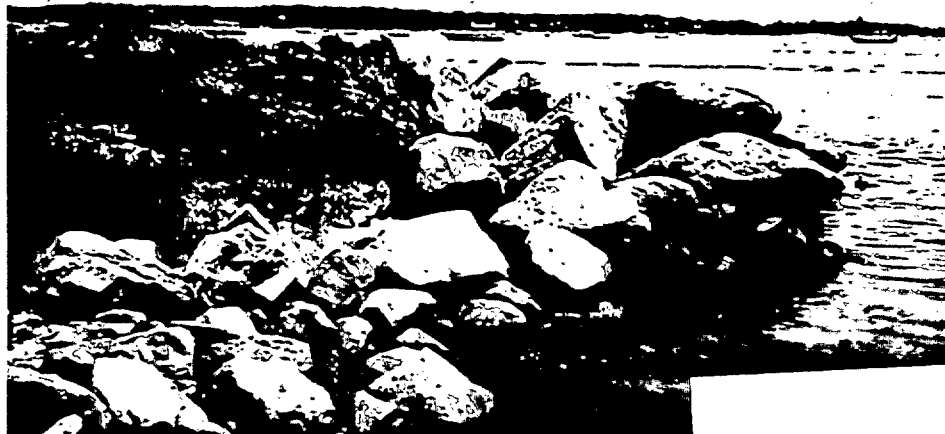
MY 103.00 #1

CONDITION: FAIR

RIPRAP HAS SOME SCOUR AND SOME CAP ROCKS HAVE BEEN MOVED

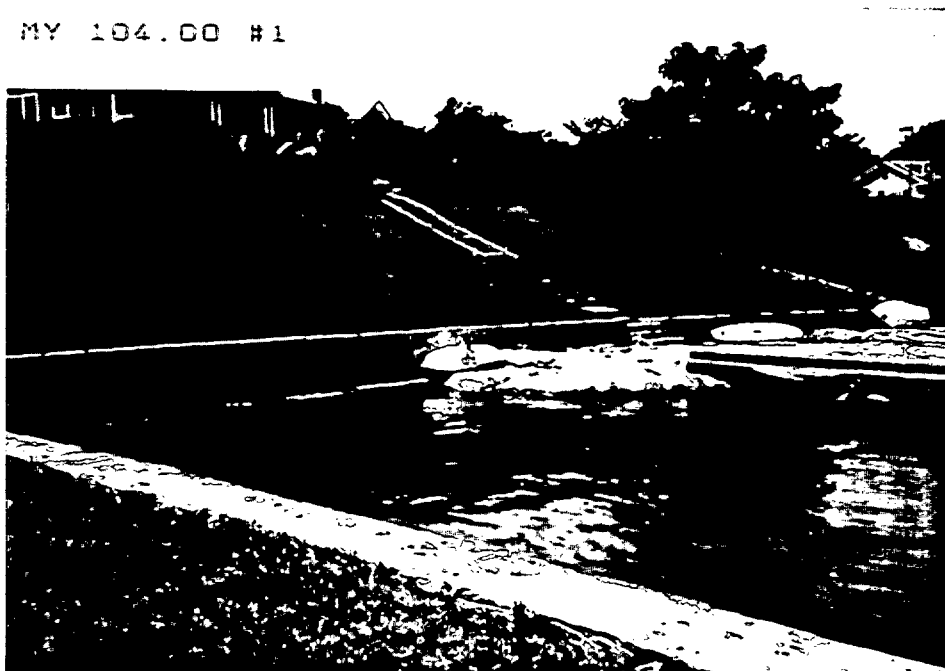
MY 104.00 #1

TYPE OF STRUCTURE: BULKHEAD CONDITION: GOOD
MAIN FUNCTION : STABILIZE SLOPE AND PREVENT EROSION
MATERIAL : STONE ON CEMENT

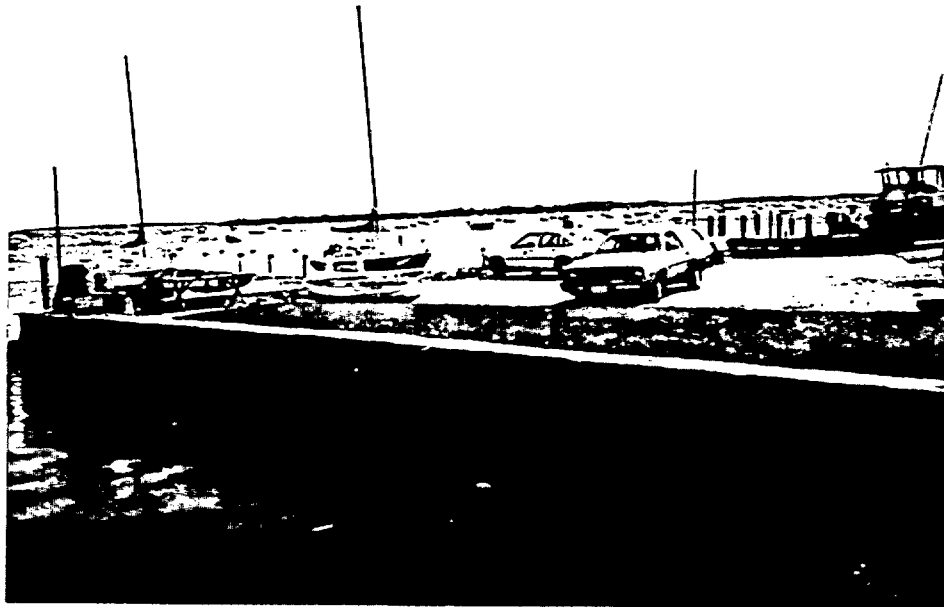
MY 105.00 #1

TYPE OF STRUCTURE: SEAWALL CONDITION: GOOD
MAIN FUNCTION : STABILIZE SLOPE AND PREVENT EROSION
MATERIAL : STONE IN CEMENT

RIPRAP PLACED UP TO MHW LEVEL AT ONE END OF STRUCTURE

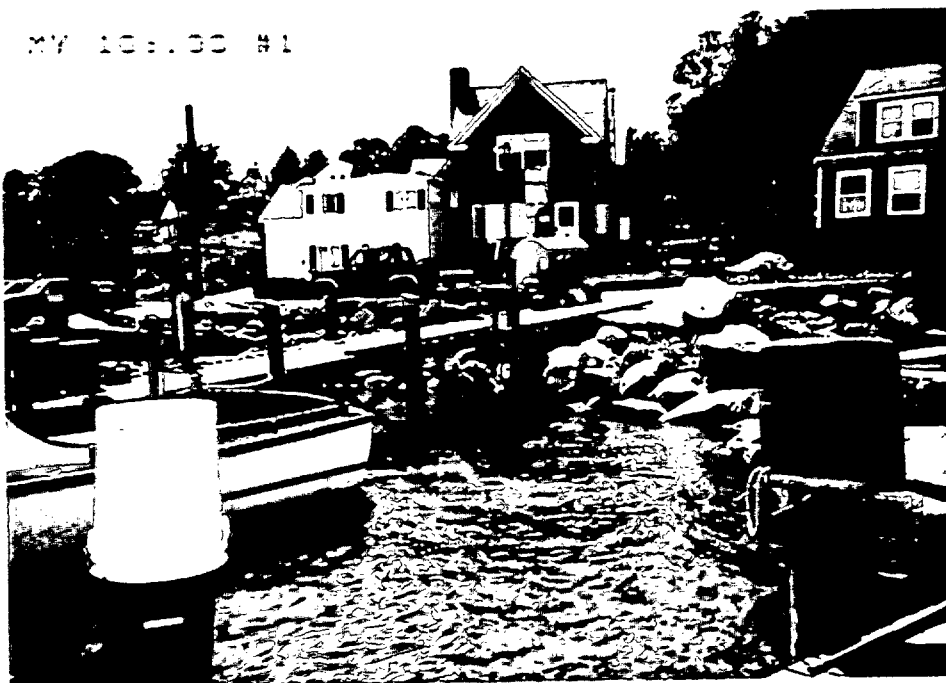
NY 10-100 #1

SOME SCOUR WITH REPAIRS DONE. PROTECTS PARKING LOT.

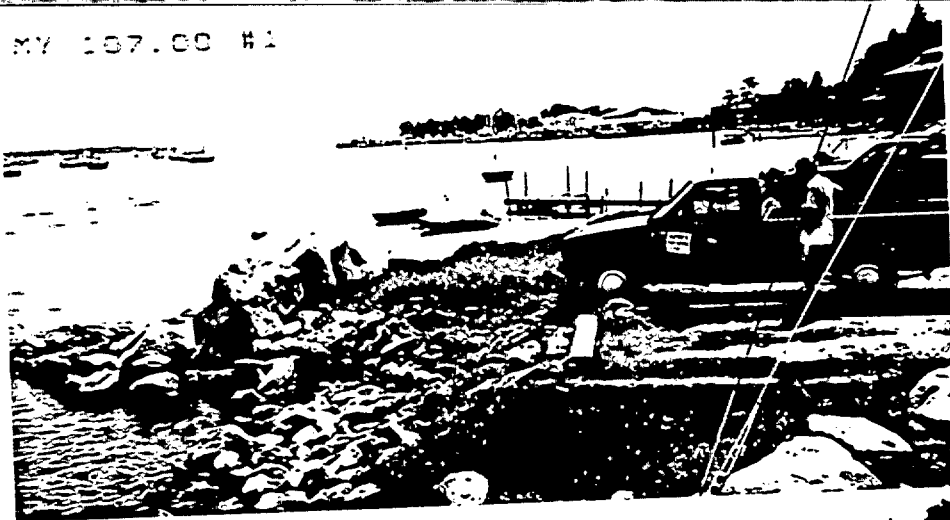
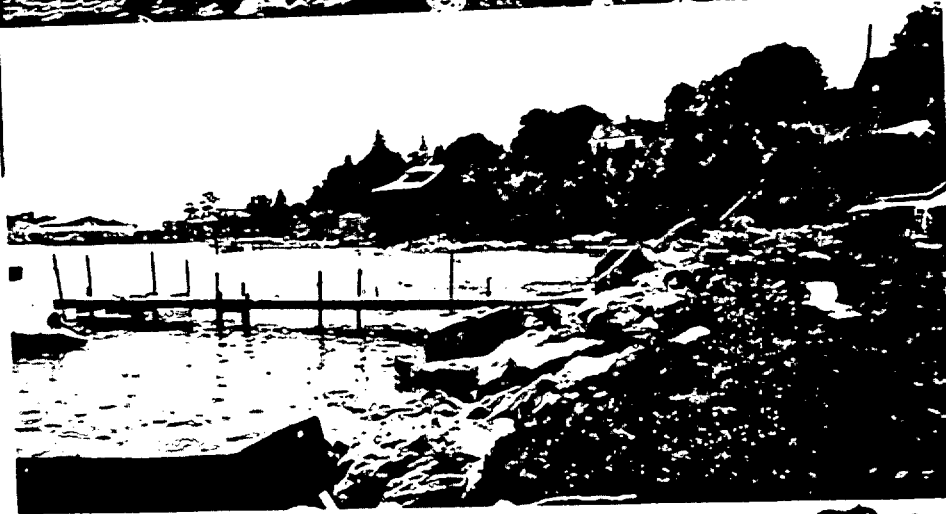
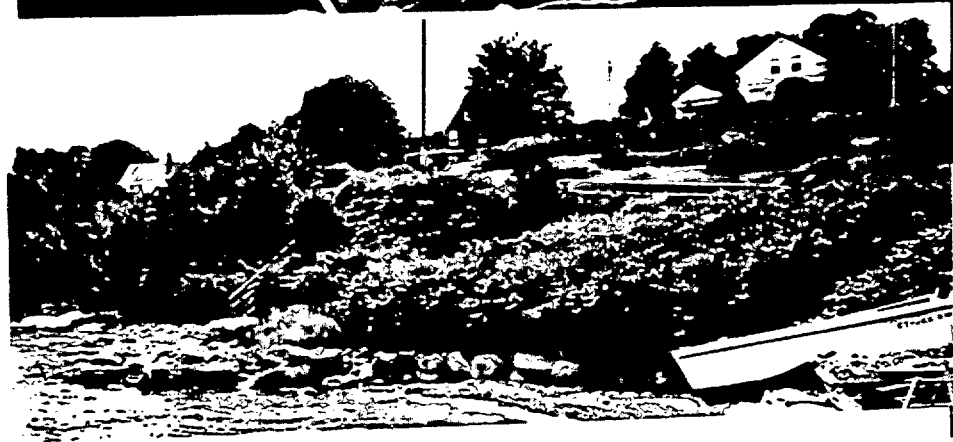
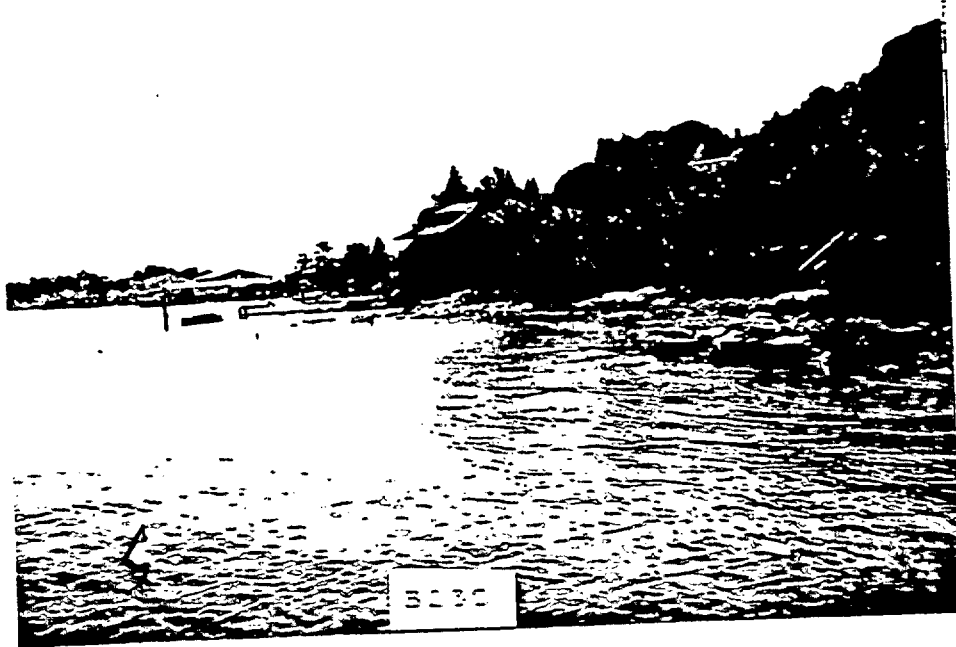
TYPE OF STRUCTURE: RIPRAP CONDITION: FAIR-POOR
MAIN FUNCTION : BANK STABILIZATION AND EROSION PREVENTION
MATERIAL : STONE

SOME SCOUR. AREA 107 IS FROM PARKING LOT (106). SOUTH TO
REVETMENT NEAR MARINA.

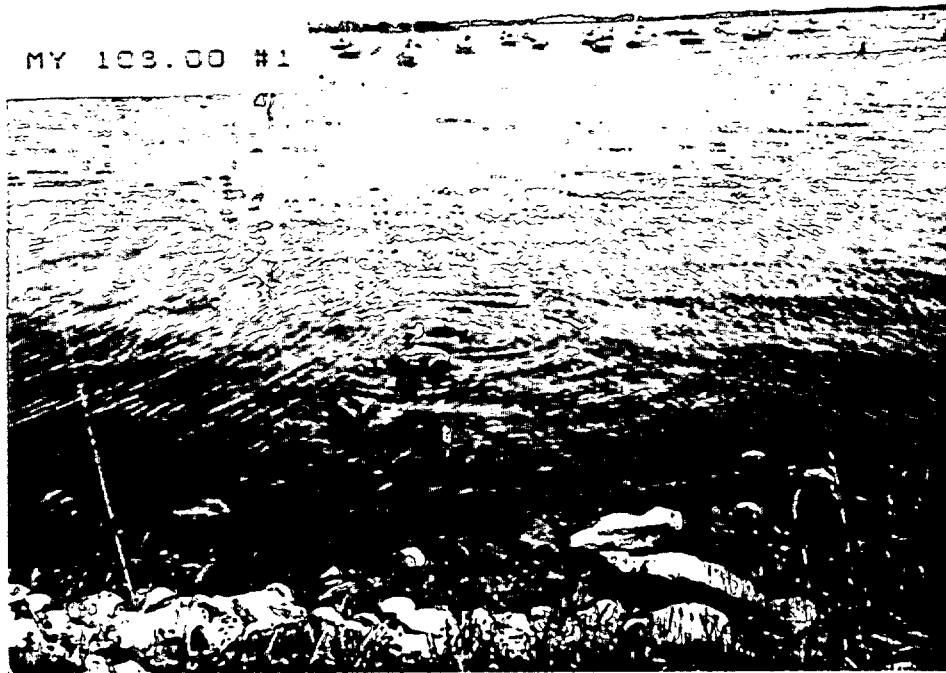
MY 103.00 #1

TYPE OF STRUCTURE: GROIN CONDITION: POOR
MAIN FUNCTION : UNKNOWN - MAY HAVE BEEN DOCK FOUNDATION
MATERIAL : ROCK

STRUCTURE SUBMERGED. MAY HAVE BEEN DOCK.

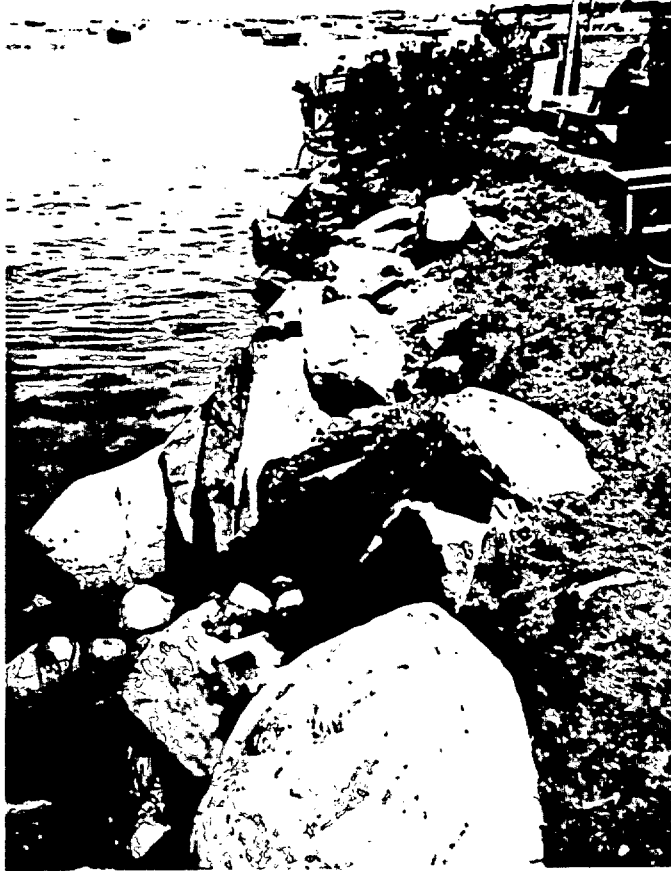
MY 109.00 #1

TYPE OF STRUCTURE: RIPRAP CONDITION: FAIR
MAIN FUNCTION : PREVENT EROSION
MATERIAL : STONE

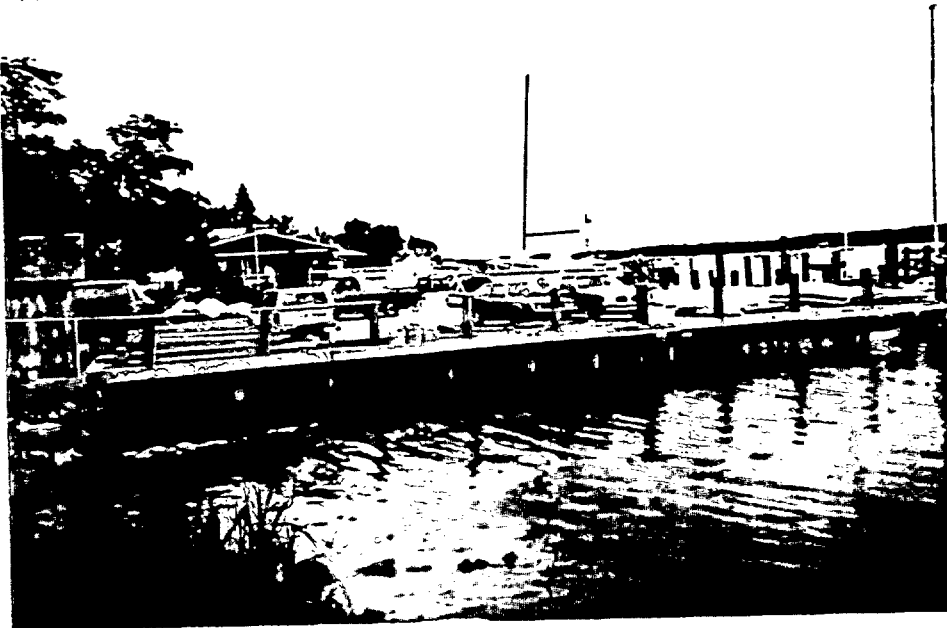
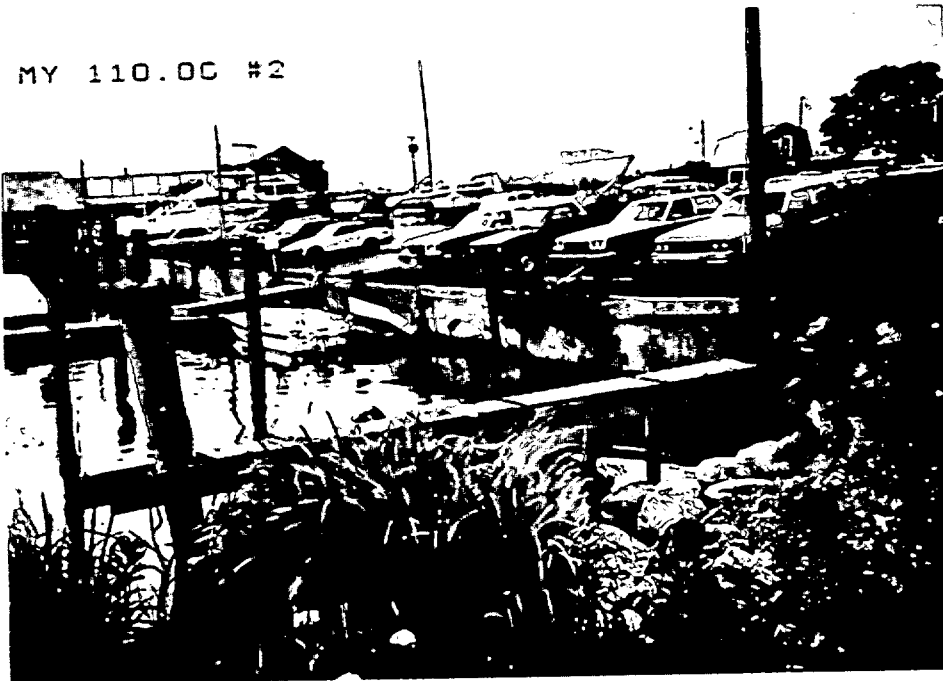
MY 110.00 #2

TYPE OF STRUCTURE: BULKHEAD CONDITION: FAIR
MAIN FUNCTION : RETAINS PARKING AREA
MATERIAL : CEMENT/STL PILE

PERMIT IS FOR PIER AND FILL NOT FOR BULKHEAD
PAVEMENT FALLING IN AT SEVERAL PLACES
